## TECHNICAL SERVICE BULLETIN

### Water Leak From A-Pillars And/Or Windshield Header

**21-2403**

<b>Ford</b> 2021 Bronco
----------------------------

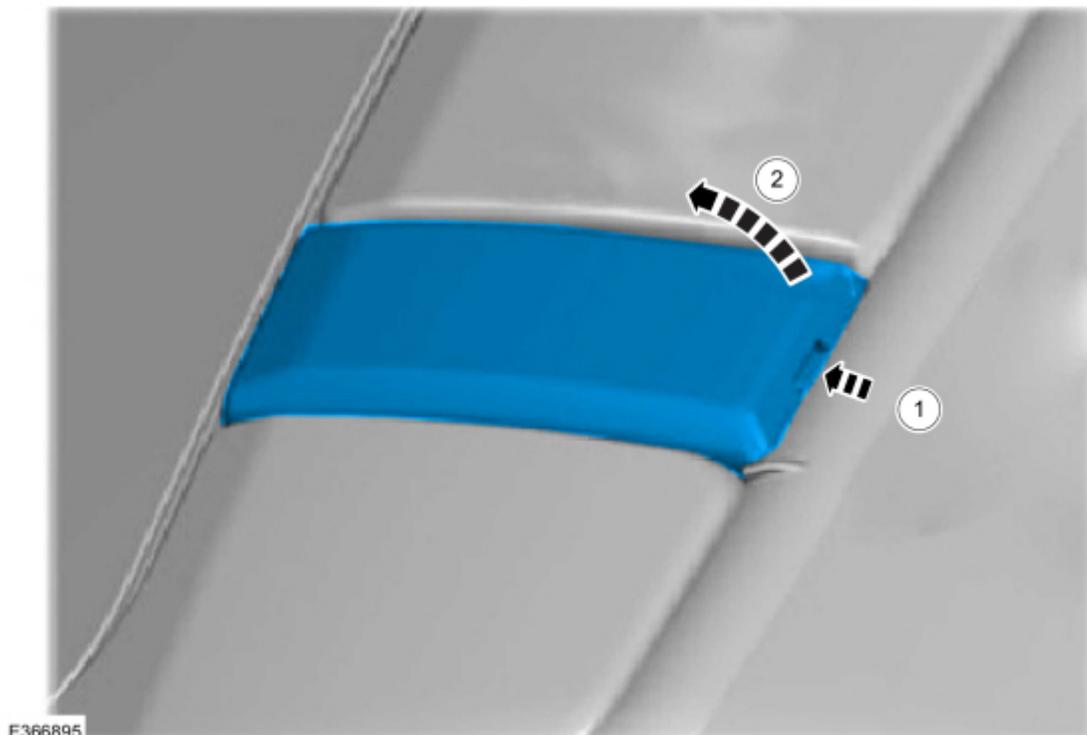
Figure 1

1. Remove both windshield trim covers by pressing the button on the rear of the cover and rotating it forward. If a roof rack is installed on the vehicle, it will need to be removed using the assistance of a second person. Refer to the vehicle's Digital Owner's Manual for removal instructions. (Figure 1)

12. Pull/remove the cord that runs along the inside of the header seal groove.
  13. Install both windshield trim covers. If a roof rack was installed on the vehicle, it will need to be reinstalled with the assistance of a second person. Refer to the vehicle's Digital Owner's Manual for installation instructions. (Figure 1)

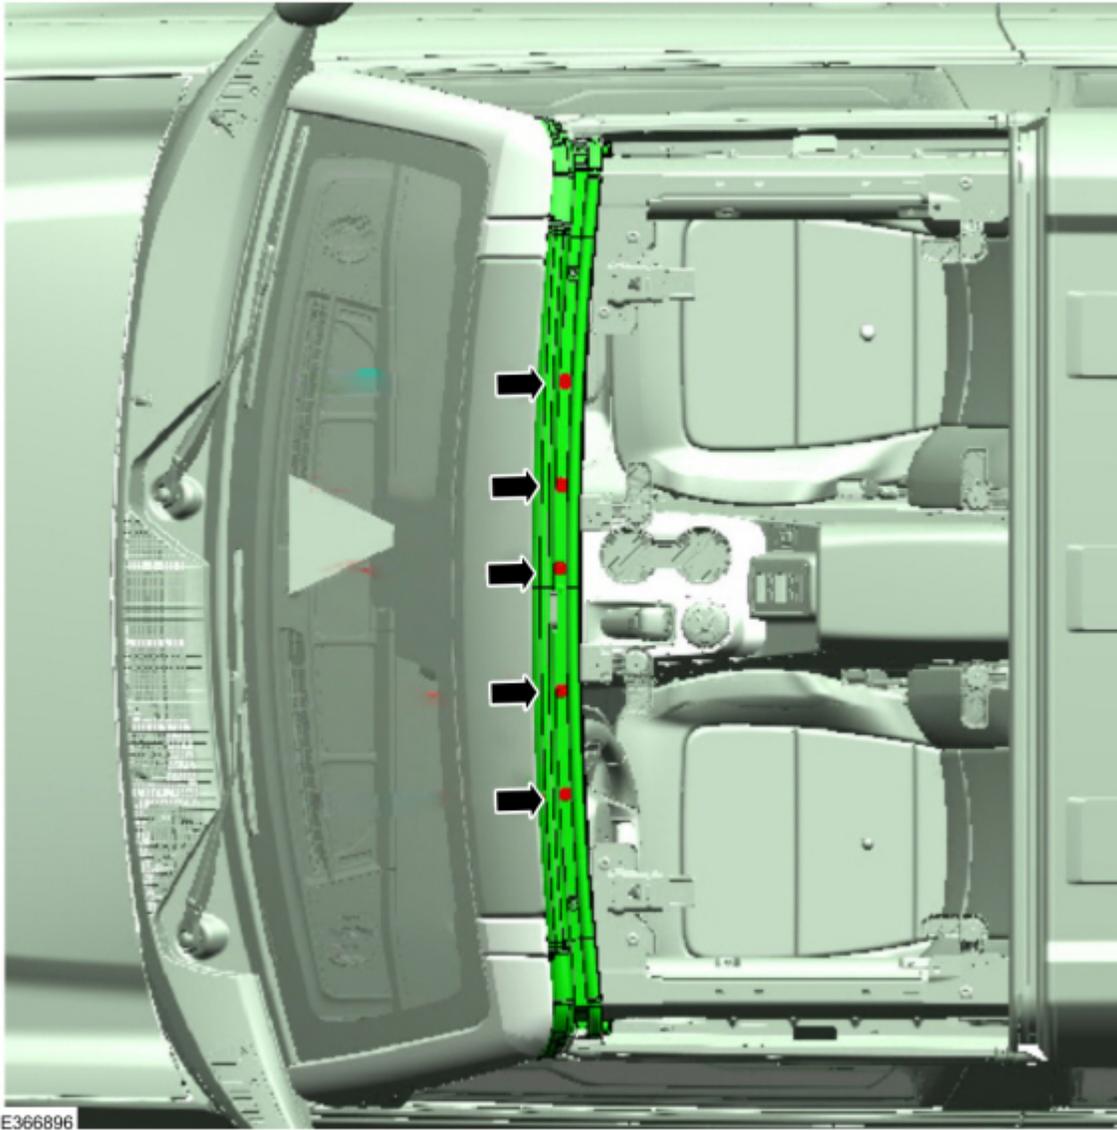
Figure 2

3. Remove the windshield header trim panel. Refer to Workshop Manual (WSM), Section 501-05, Interior Trim and Ornamentation > Removal and Installation > Windshield Header Trim Panel.
4. Remove the header seal.
  - (1). Remove the 5 center bolts and nuts securing the header seal to the body. (Figure 2)

9. Install all header seal attachments.
    - (1). Tighten the 5 center bolts and nuts securing the header seal to the body to 9 Nm (80 lb-in). (Figure 2)

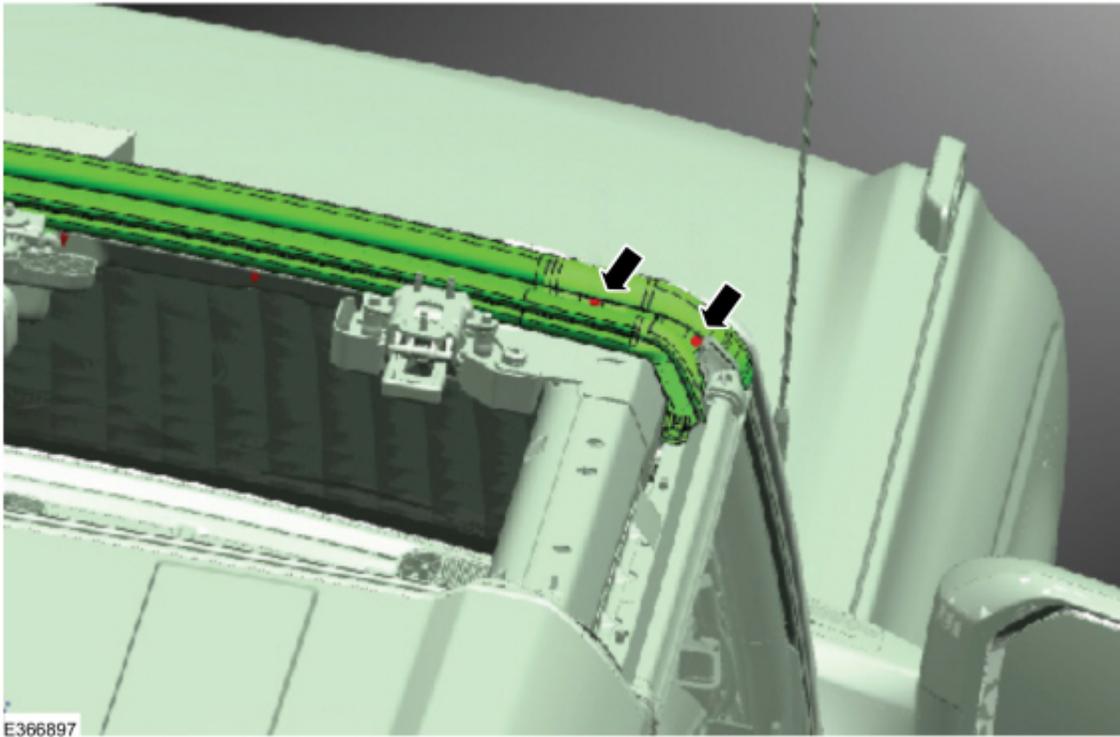
Figure 3

(2). Remove the 4 bolts (2 on each side) securing the header seal to the body. (Figure 3)

- (2). Tighten the 4 bolts (2 on each side) securing the header seal to the body to 3 Nm (26 lb-in). (Figure 3)
    - (3). Install the 2 pushpin fasteners, 1 located at each end. (Figure 4)

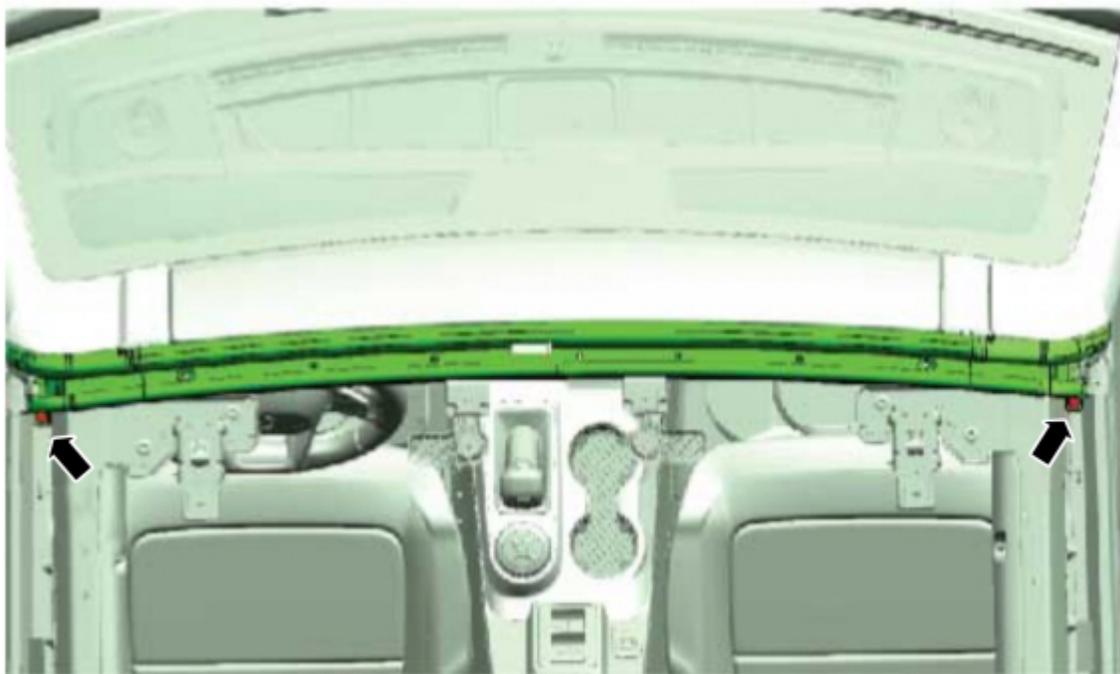
Figure 4

(3). Remove the 2 pushpin fasteners (1 on each end). (Figure 4)

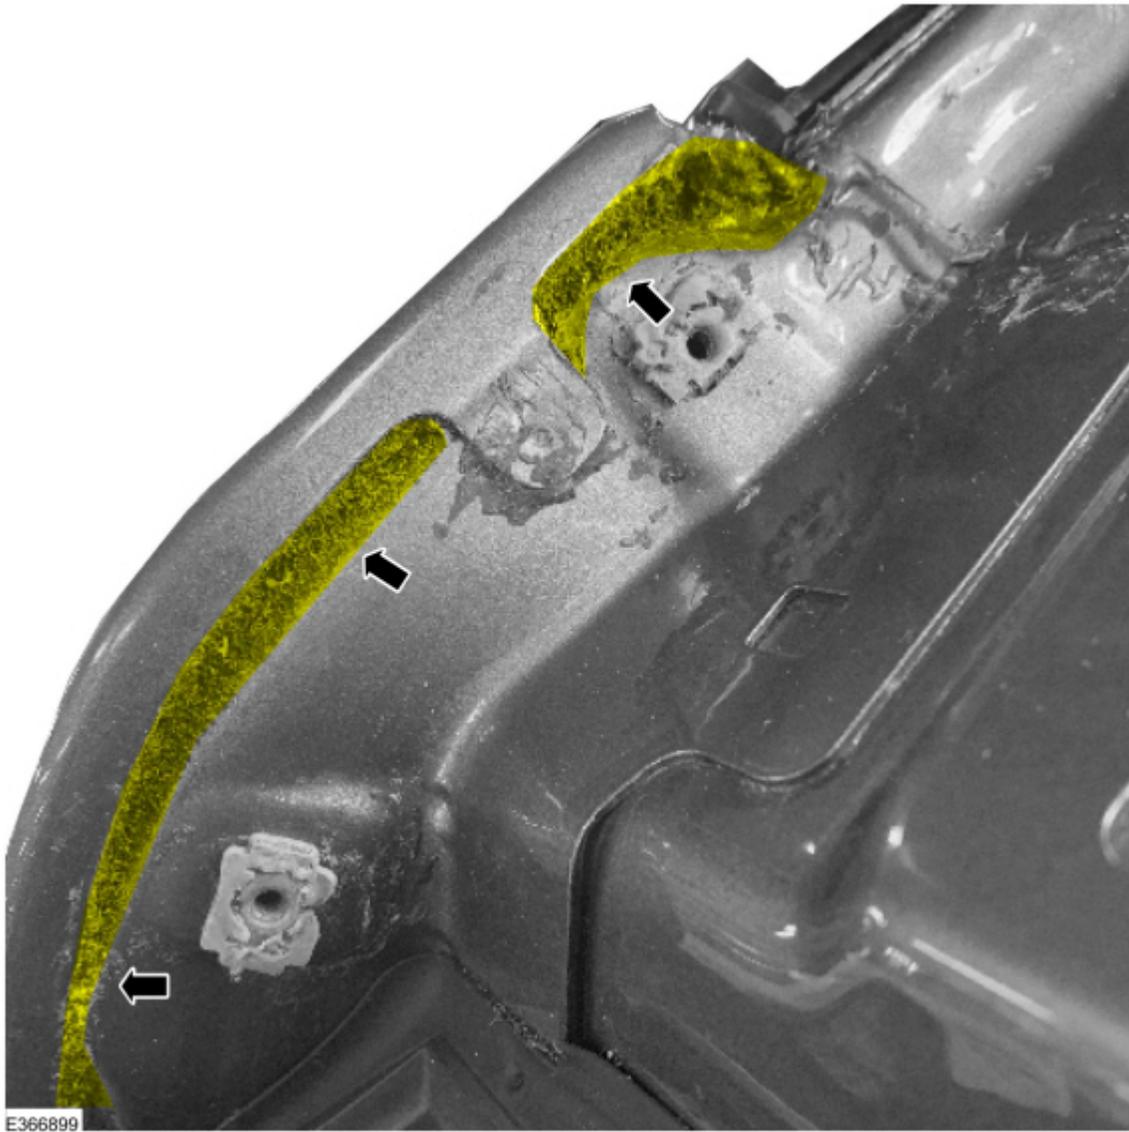
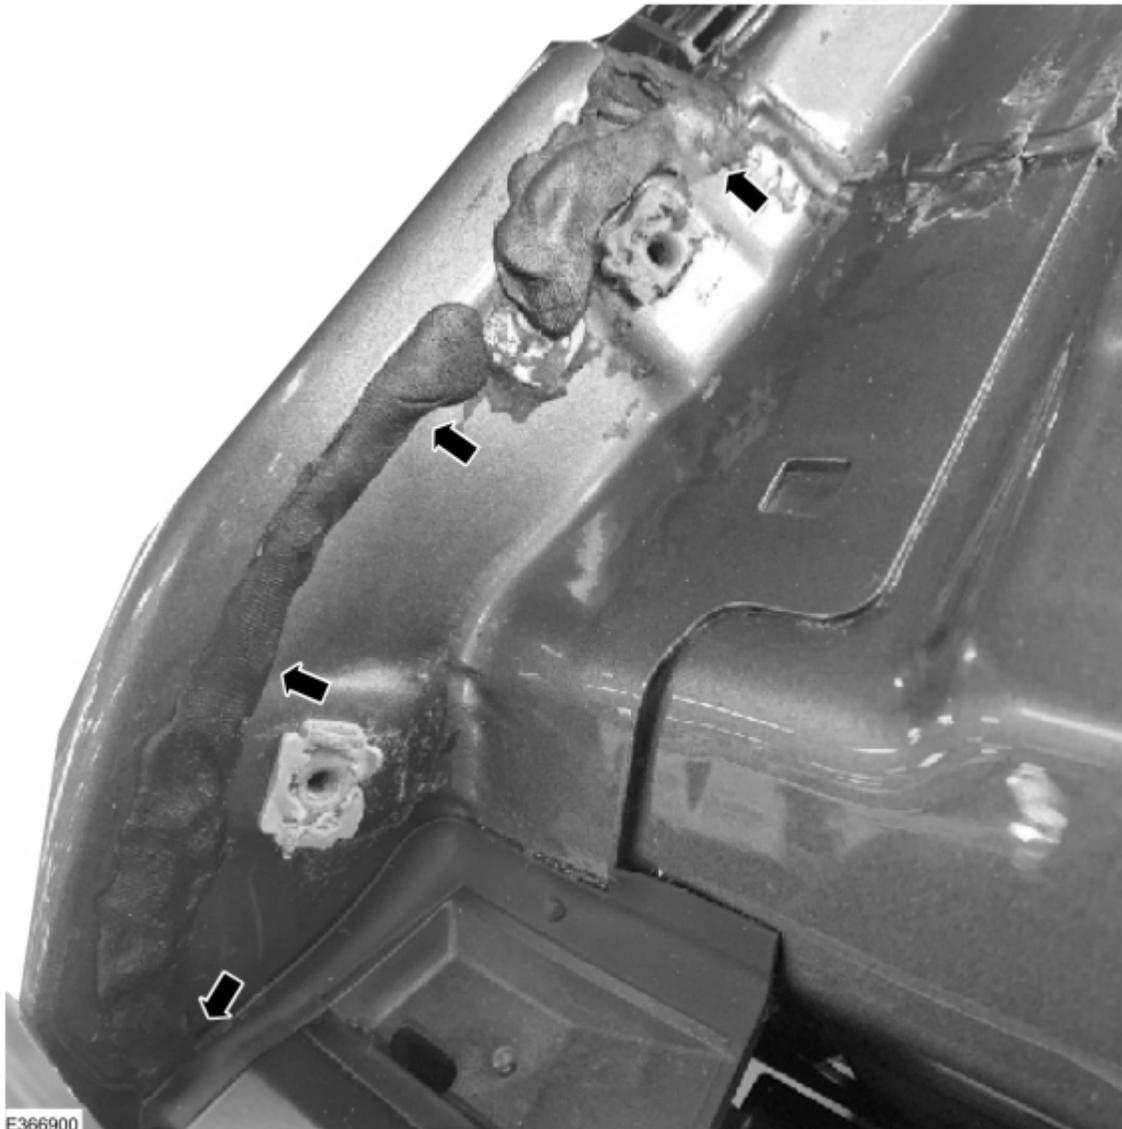
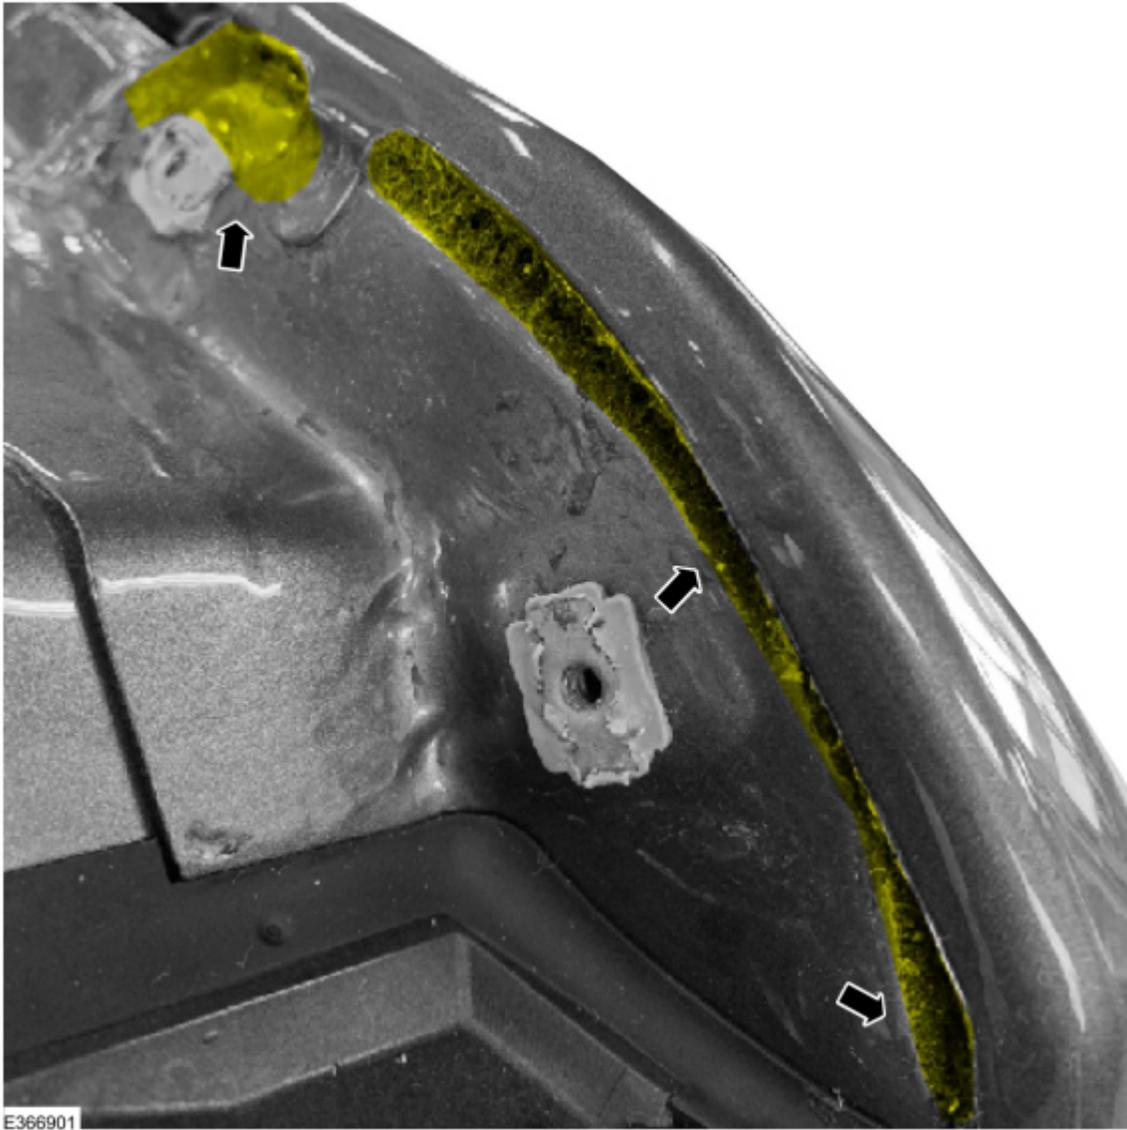
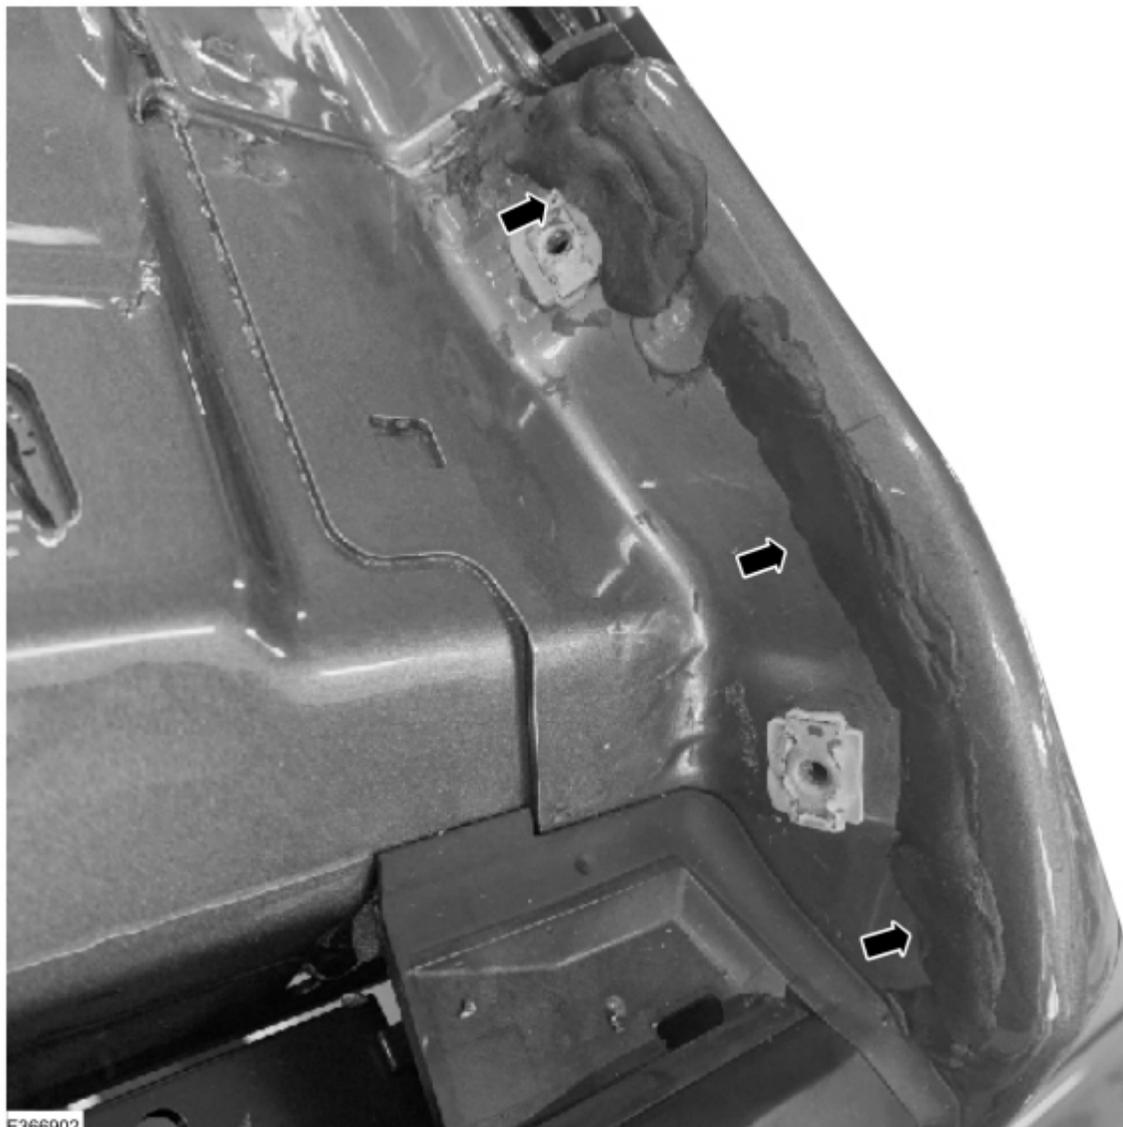
5. Clean the header seal mating surface on the body by removing all residual sealer left over from the old header seal. Use a plastic scraper and isopropyl alcohol wipes to clean the surface without harming the painted surface. If any painted surfaces are scratched during the cleaning process, touch up these areas with paint (covering any exposed metal) prior to proceeding.
6. Follow the instructions on the container to apply 3M™ Strip-Calk to the exposed body seams starting at the roof rack trim cover area and ending at the corner seal where the body seam ends. Do not leave a gap between the edge of the caulk and the corner seal. (Figures 5-8)
